① BUREAU OF SHIPS GROUP
TECHNICAL INSPECTION REPORT

(6) OPERATION CROSSROADS.

FAILURES OF MASTS, YARDARMS,
BOOMS AND RIGGING [U.]

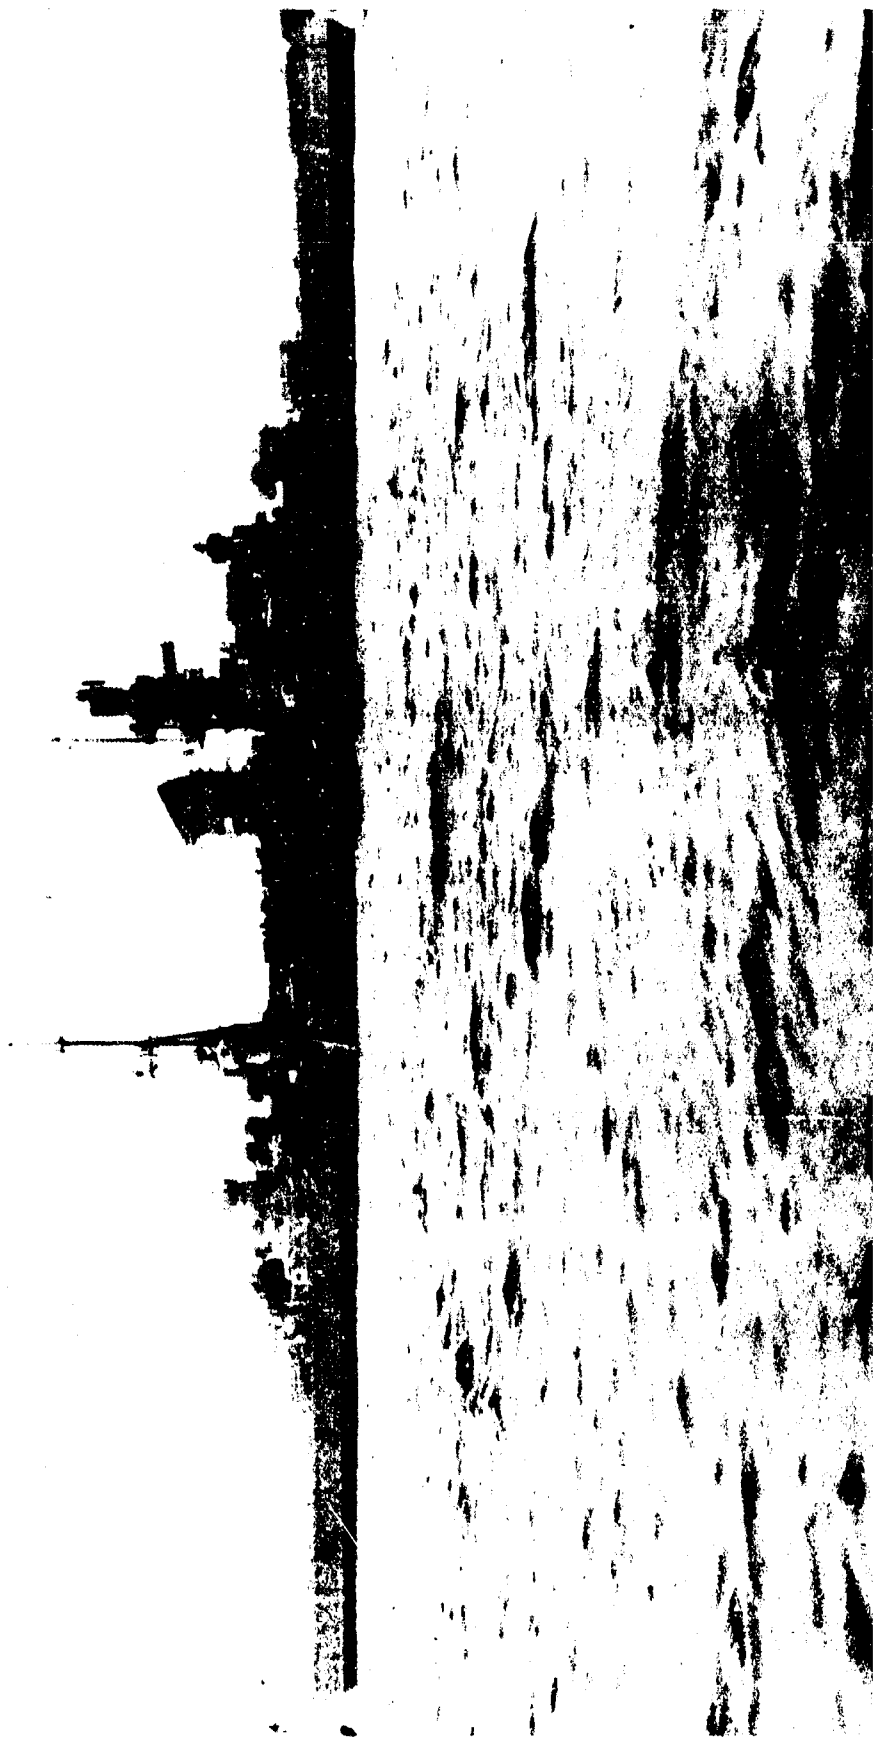
AA-CR-227-92-101. PRINZ EUGEN (IX300). View looking at starboard beam after Test Able. Note that main topmast has been broken off.

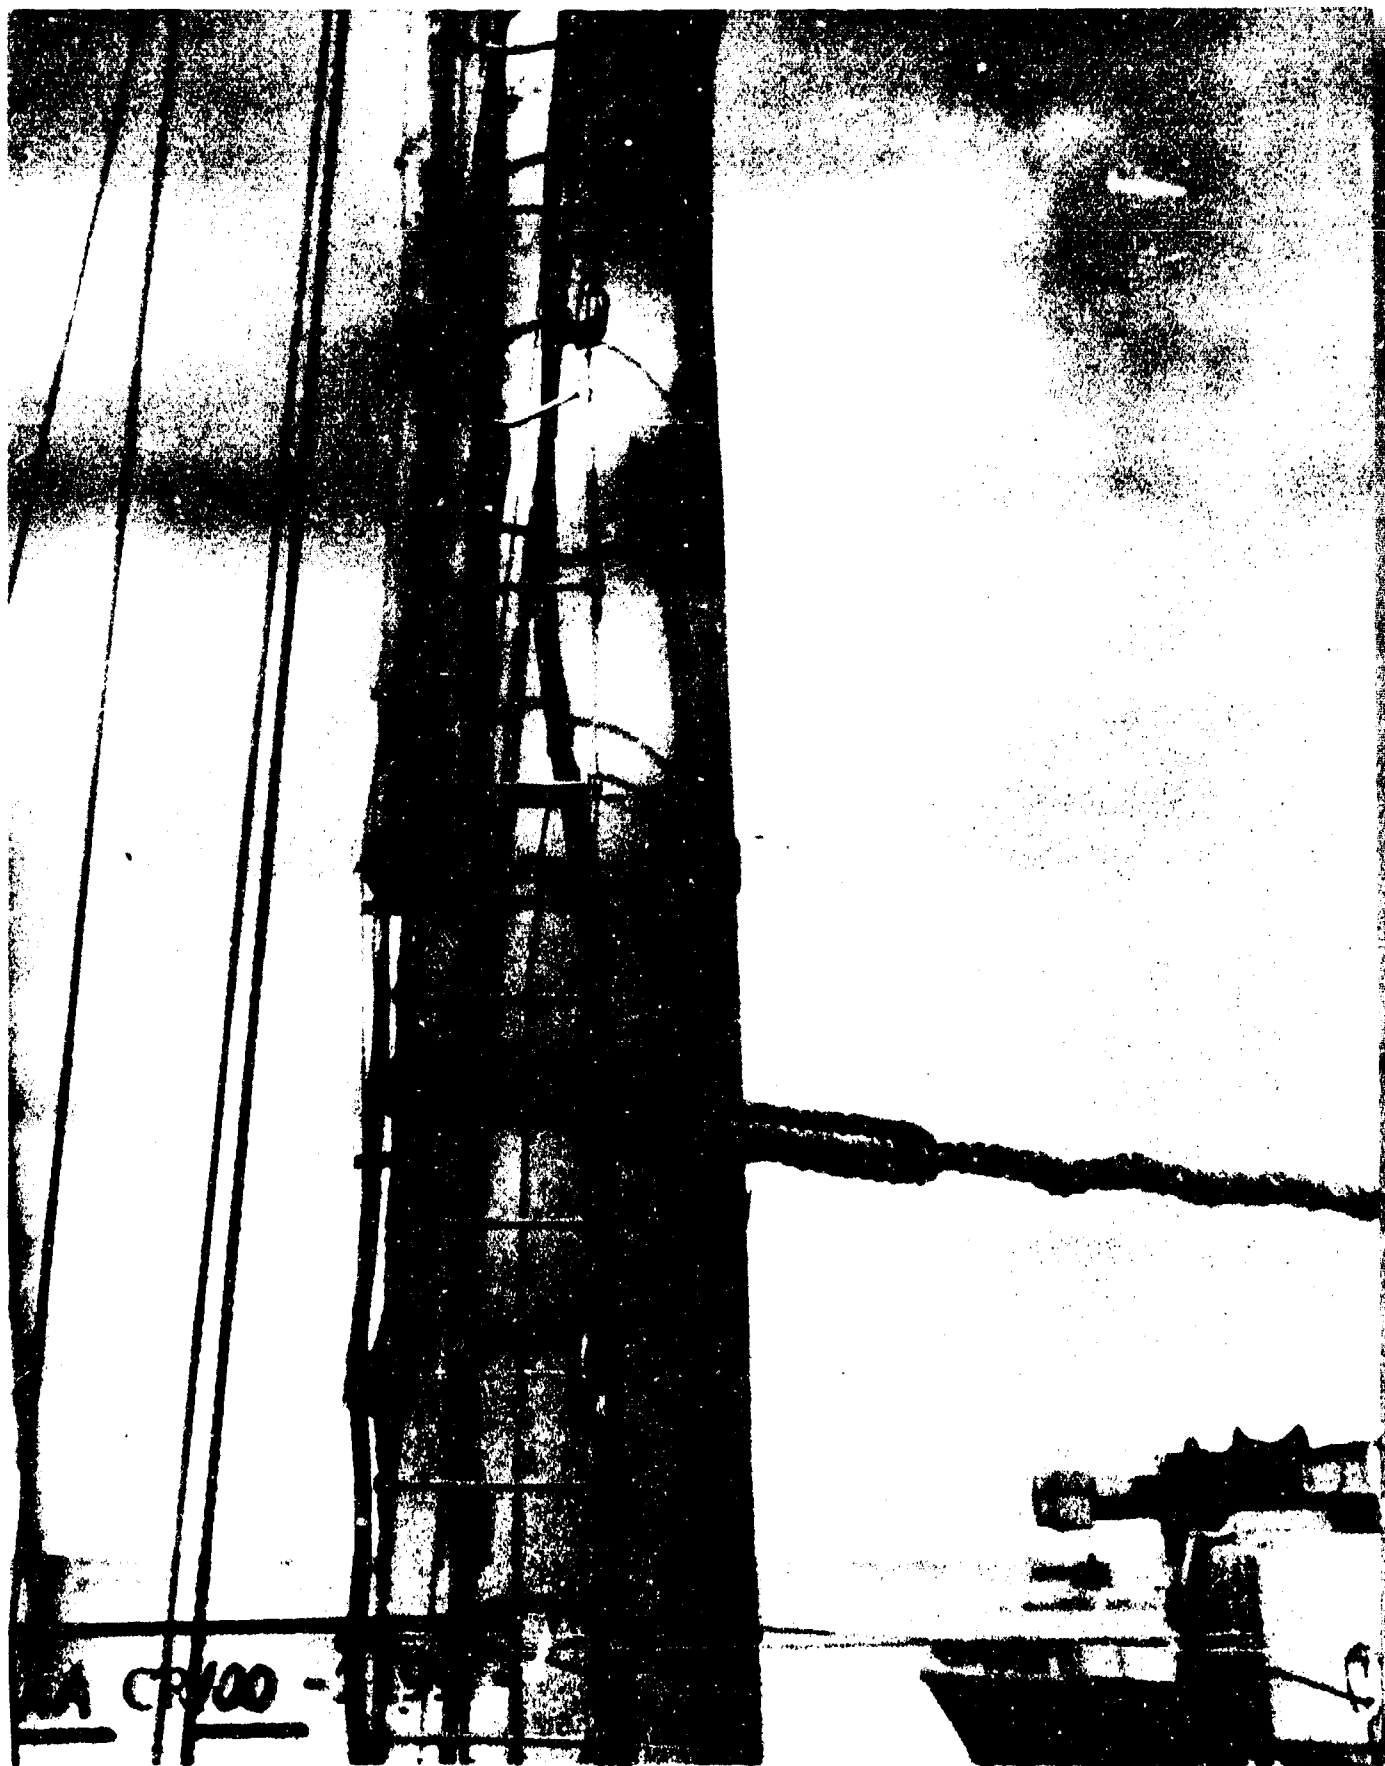
AA-CR-100-2199-1. PRINZ EUGEN (IX300). Continuation of crack shown in 2200-12.

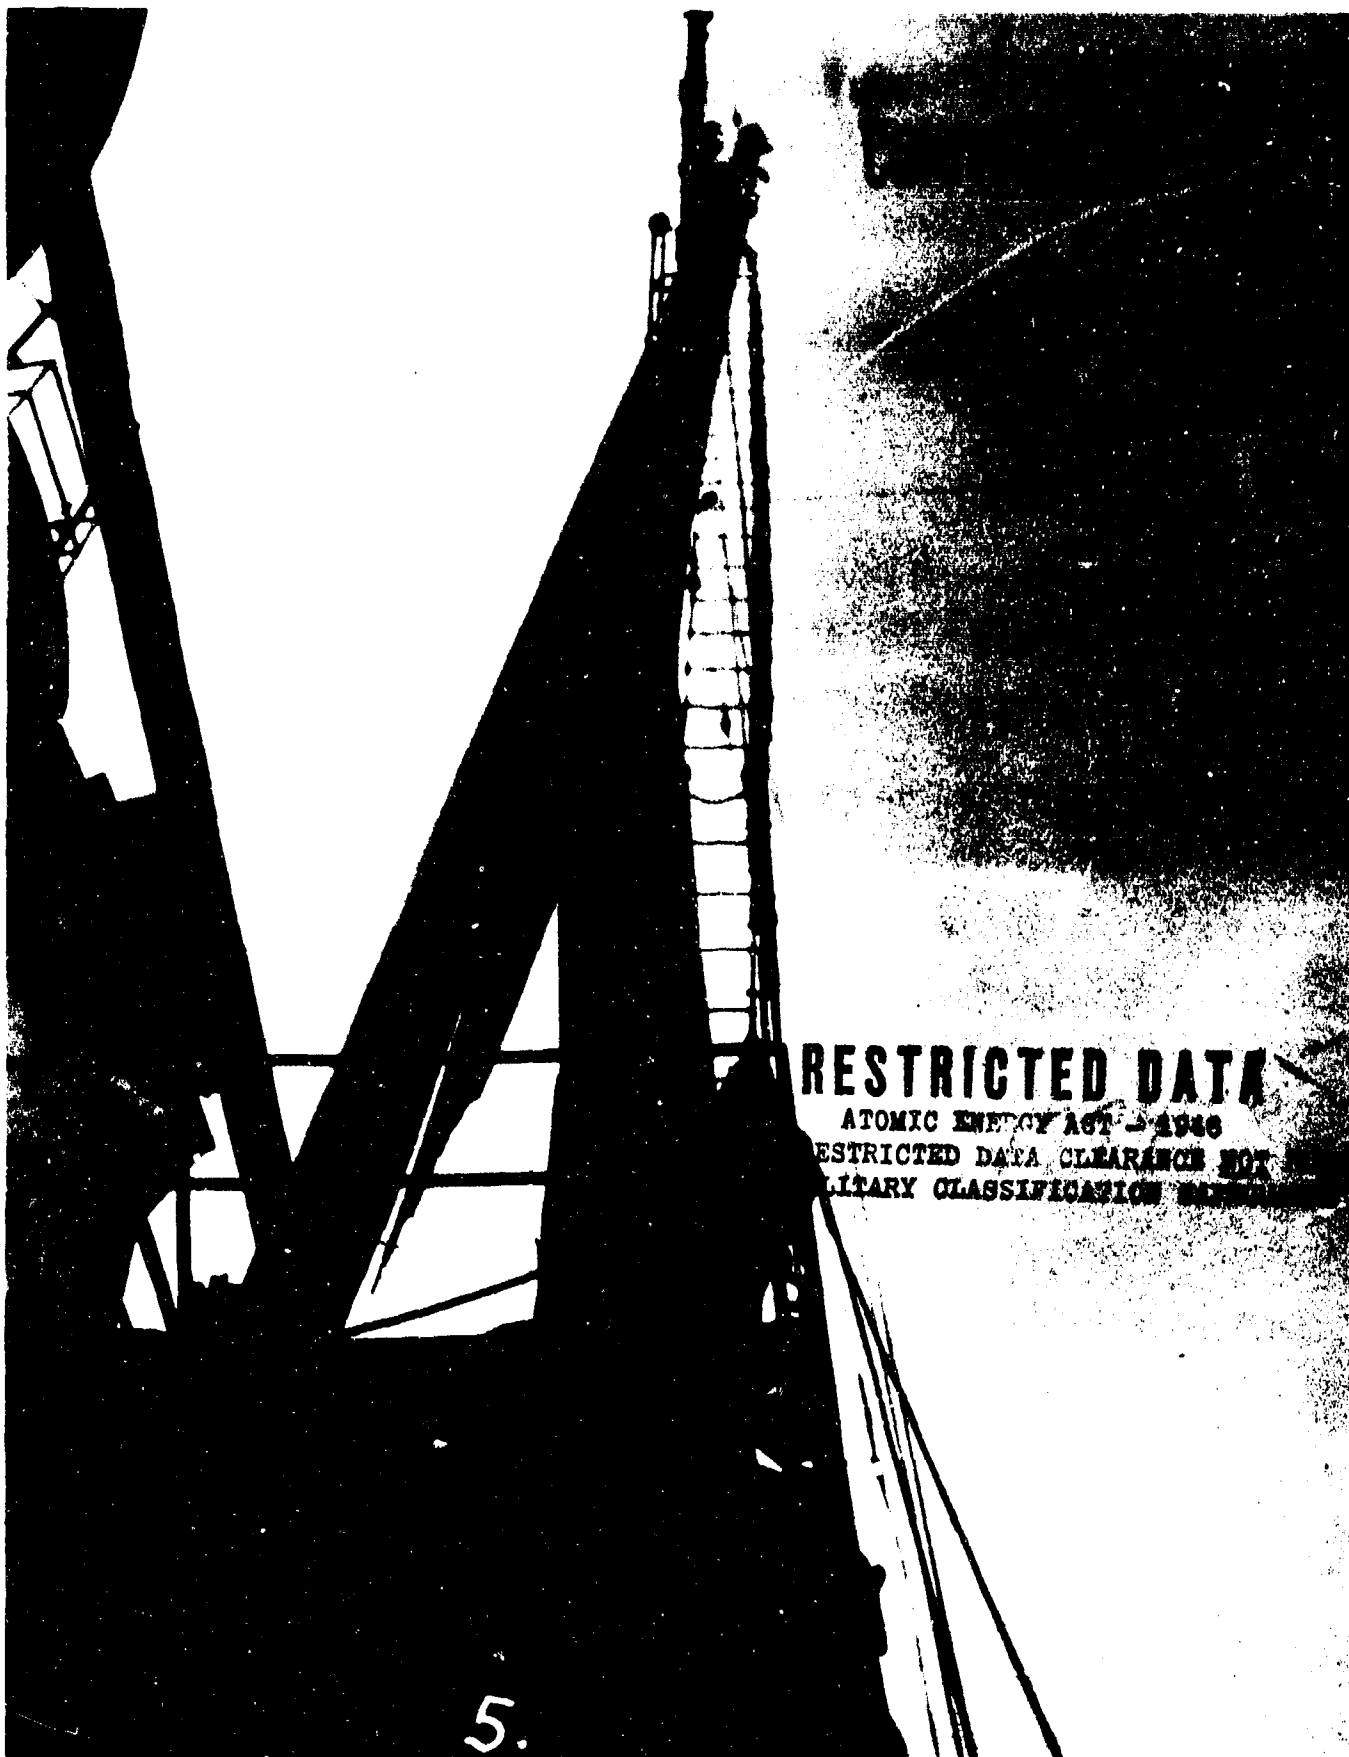
AA-CR-92-1774-5. PRINZ EUGEN (IX300). Broken mast, looking up,
after Test Able.
